Manhole Inspection Summary

Manhole # S13W__004MH

Insp Date: **1/9/09 1:30 PM**

Location Address: **Wilso Dr.**

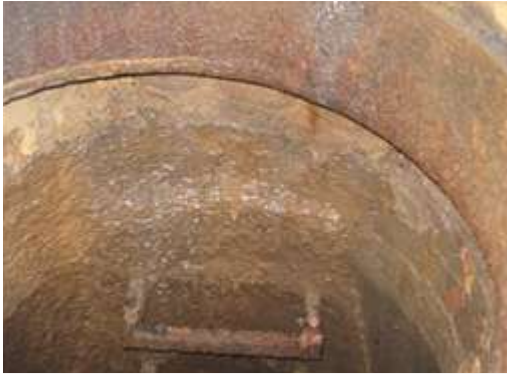
Defect 8

missing mortar causing chimney infiltration

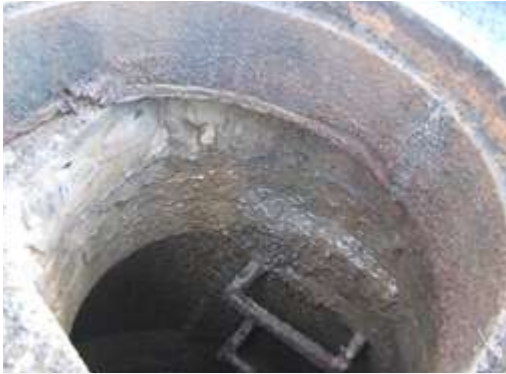
Defect 7

active infiltration at the chimney

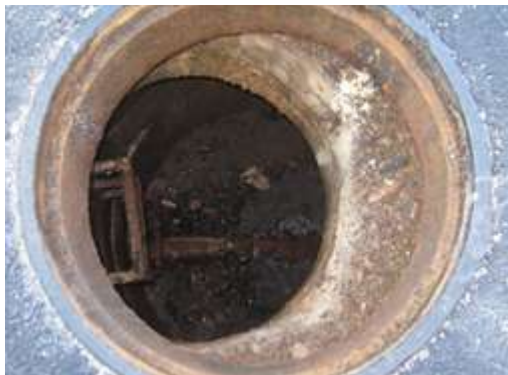
Defect 6

frame offset

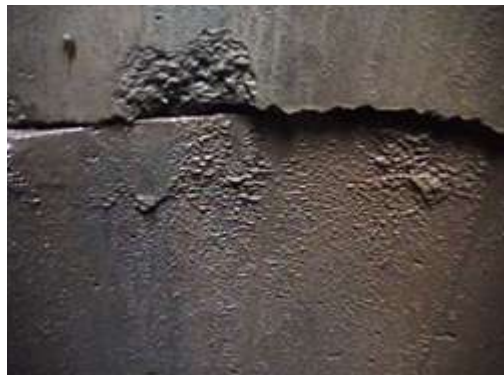
Defect 5

barrel infiltration at the joint

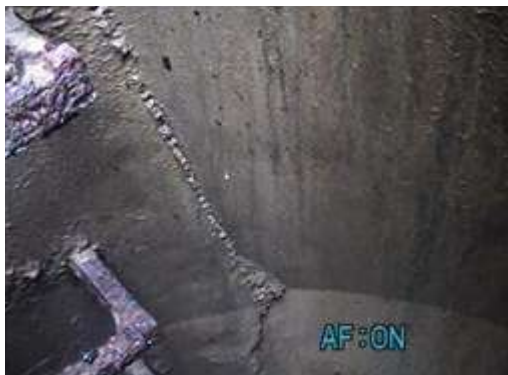
Defect 4

crack in the corbel and barrel

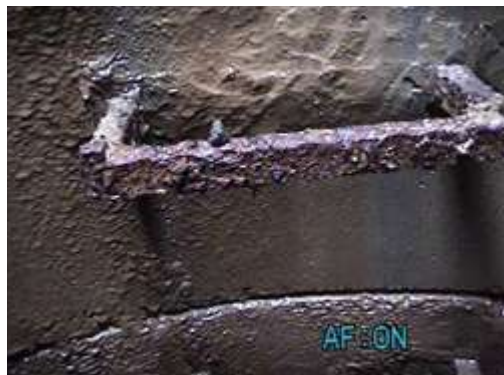
Defect 3

corroded rung and corbel infiltration

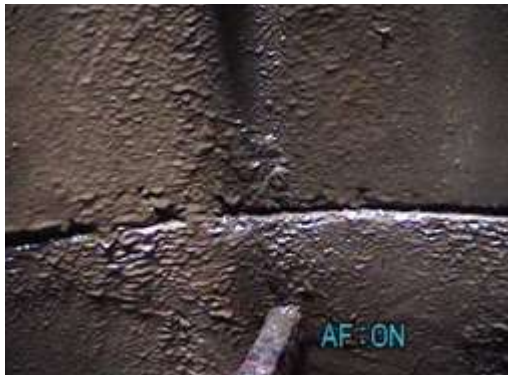
Defect 2

corbel infiltration at joint

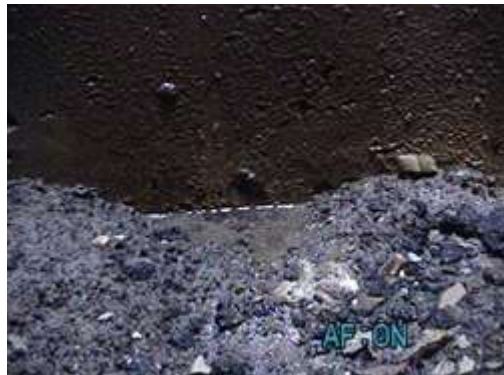
Defect 1

barrel infiltration

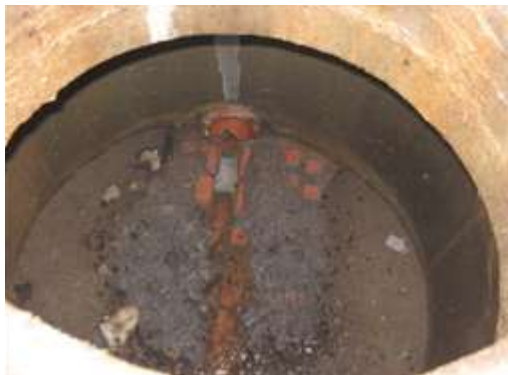
Defect 9

Channel Debris
